3408 Turnstone Drive
Victoria BC
V9C 0B4

Prepared For: TBA
Prepared By: David Fletcher #62502
Date: August 24th, 2020

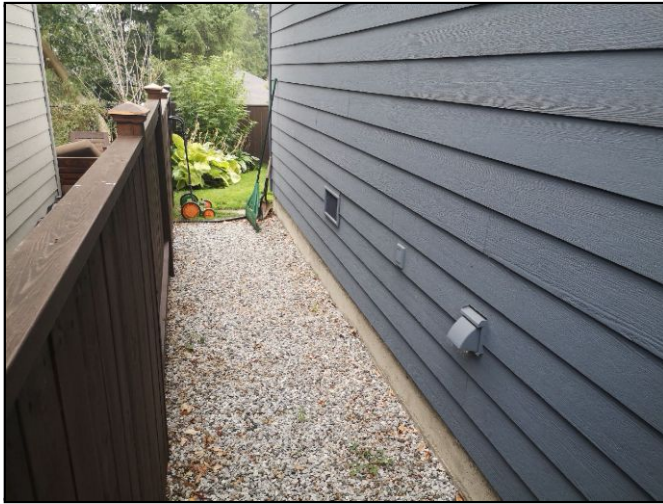
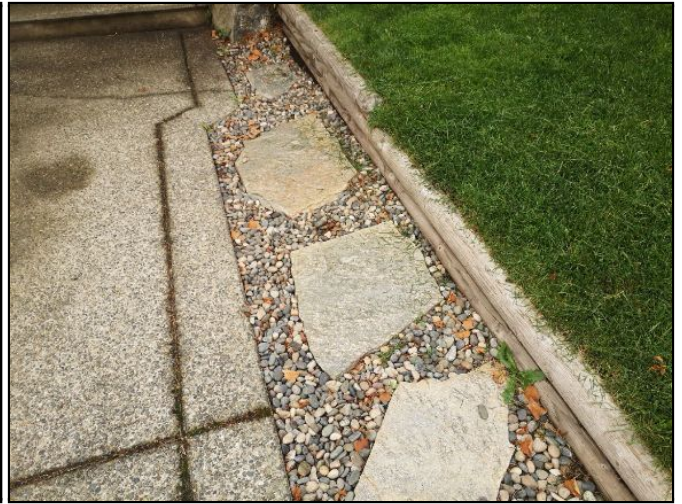
Walks:2:

Material / Type: Stone and gravel areas
Status: Fall hazard areas noted along rock side at rear of home

Implications: Fall hazard
Recommendations: Use caution around area, especially for children

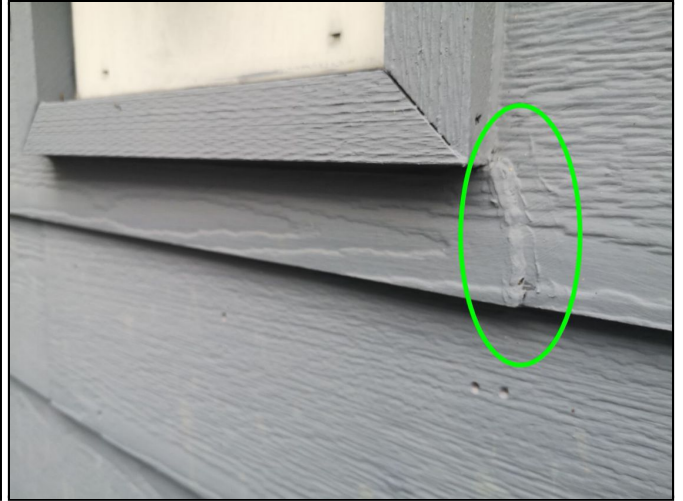
Siding:

Material / Type: Cementitious Fibre Board
Status: Minor cracking noted in select areas, Recently painted

Implications: Cosmetic

Recommendations: Monitor for any damages or loose boards, Ideally seal cracks, appeared some maintenance had been done

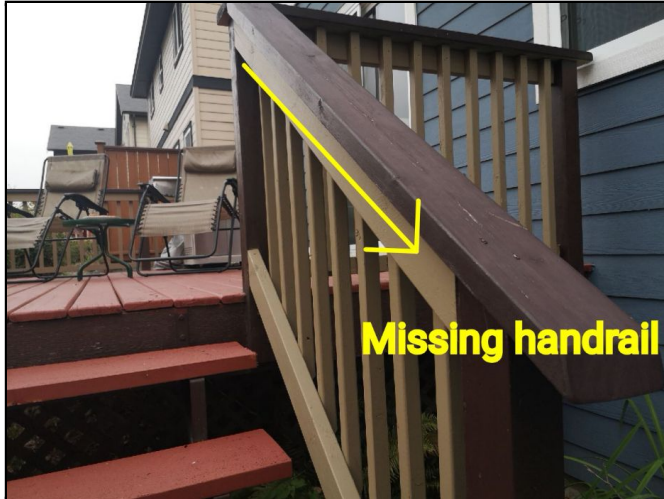
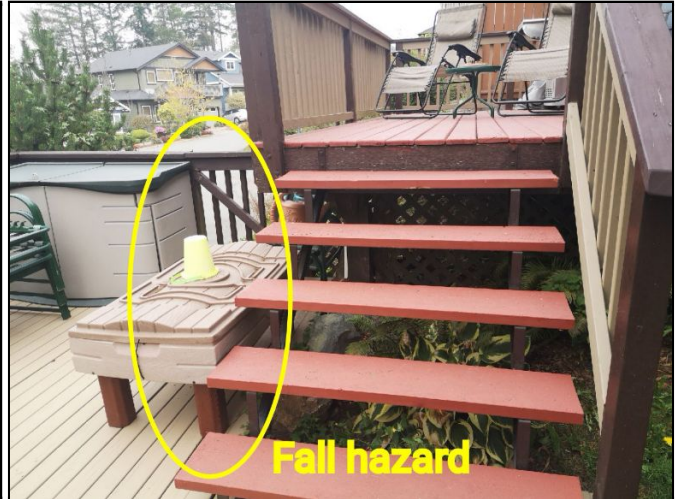
Stairs:

Material / Type: Wood, Pressure treated
Description: Deck stairs
Status: Missing Handrail, Missing Guardrail

Implications: Fall hazard
Recommendations: Use caution, consider improvements

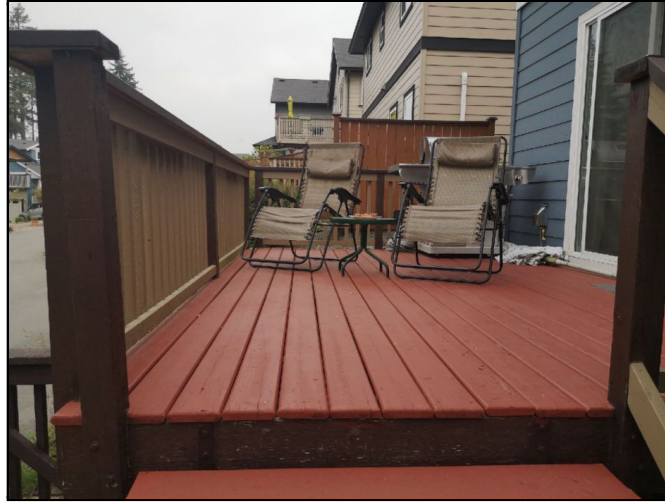
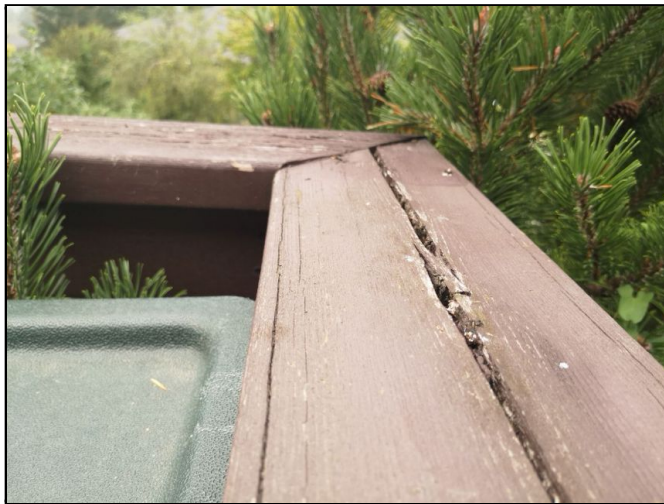
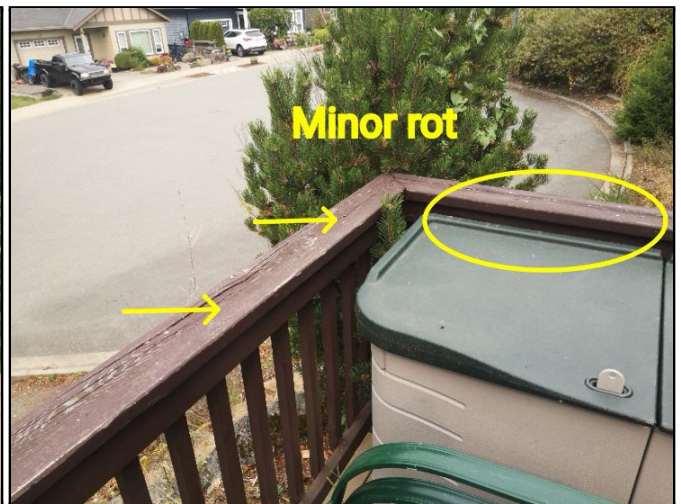
Exterior

Status: Acceptable, Minor rot noted to top cap railing in lower patio area

Recommendations: Keep up with maintenance, minor repairs may be needed in upcoming seasons

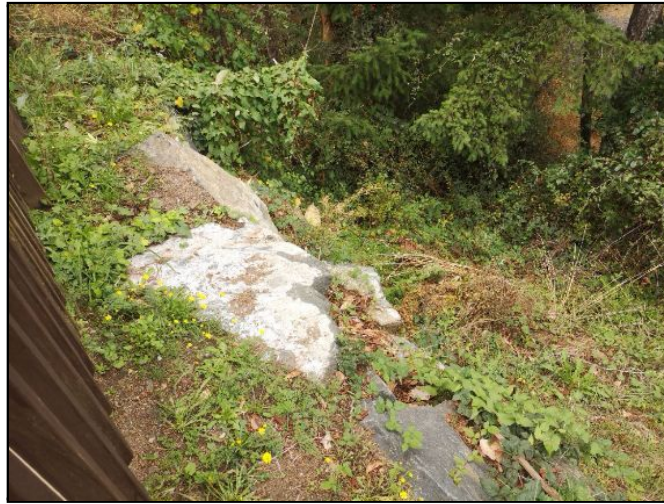
Retaining Wall:

Material / Type: Stone
Status: Acceptable

Recommendations: Monitor for invasive plant species,
remove as needed

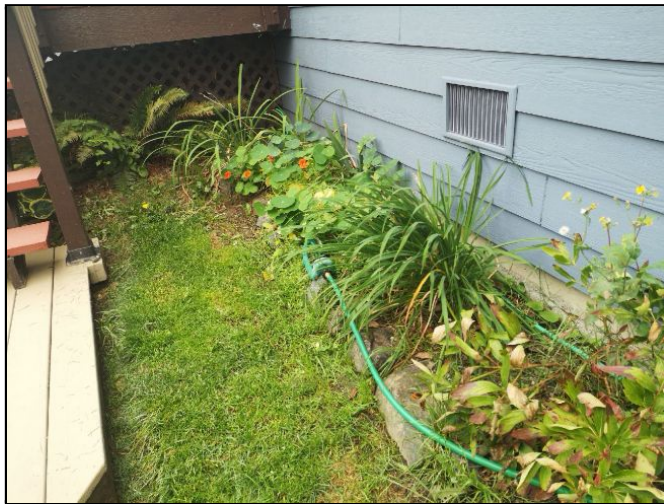
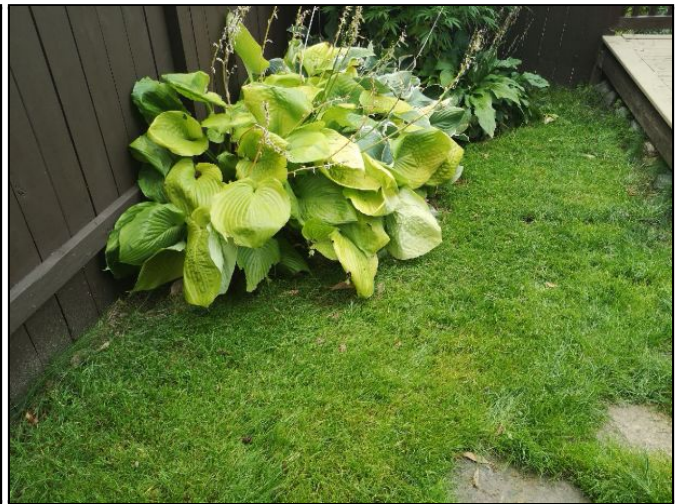
Grading:

Material / Type: Flat, Slight slope
Status: Acceptable

Recommendations: Perimeter drains not inspected,
consider further evaluation

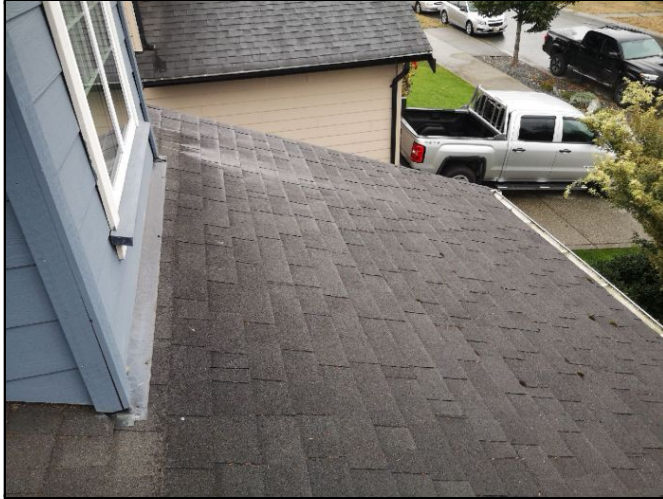
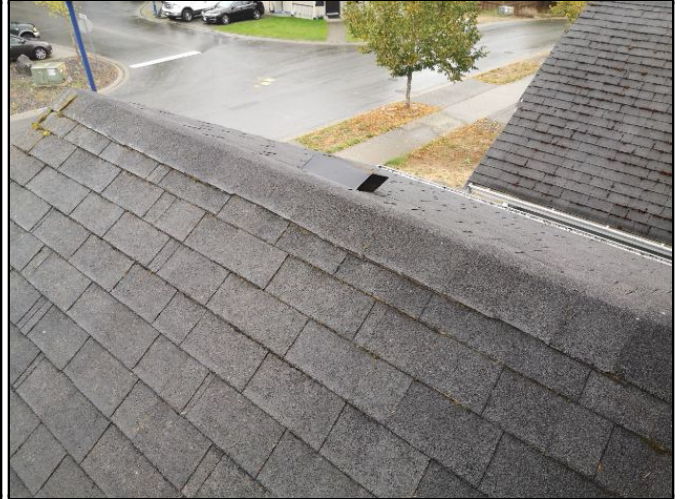
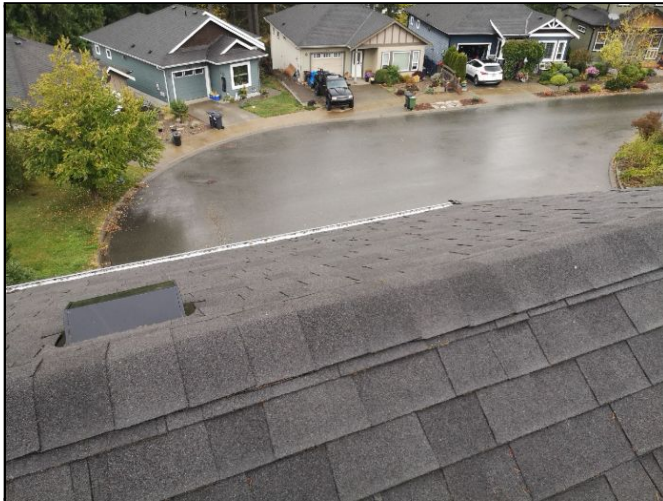
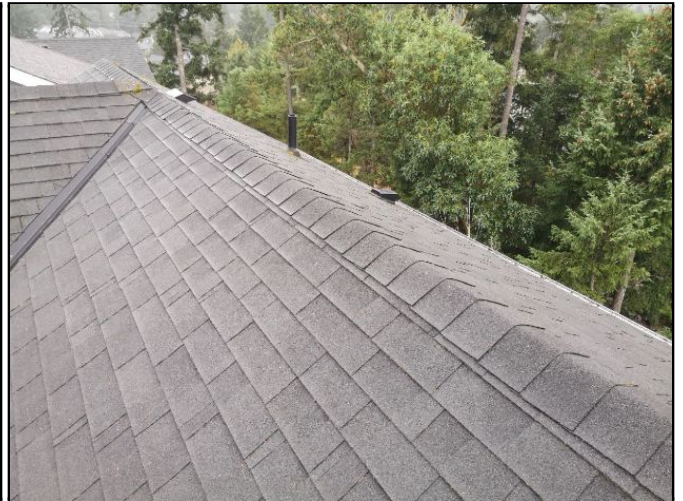
Roof:

Material / Type: Fibreglass Shingle

Status: Acceptable, Signs of previous moss growth

Implications: Premature Deterioration

Recommendations: Treat and clear roof surface of moss annually

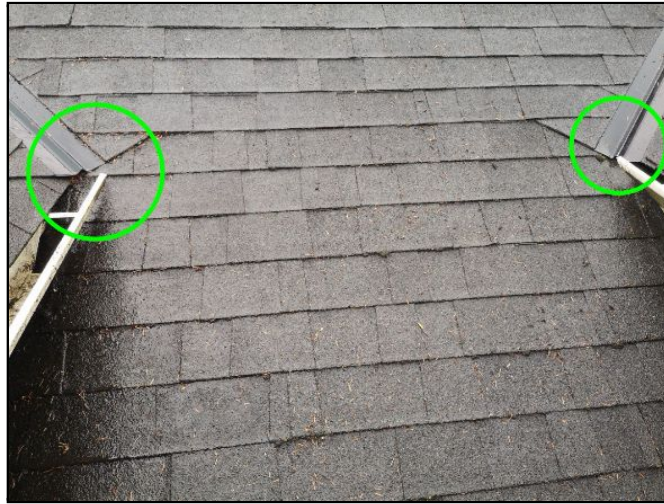
Gutters:

Material / Type: Aluminium
Status: Acceptable

Recommendations: Back gutter needs cleaning

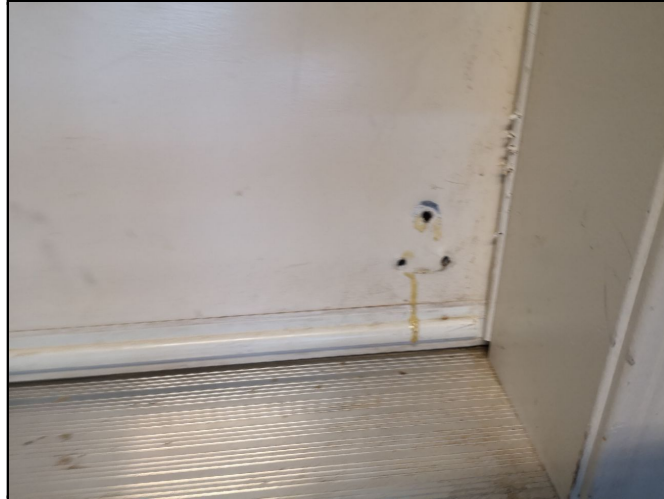
Doors:

Status: Acceptable, Minor damage noted, appears a door stop may of been installed

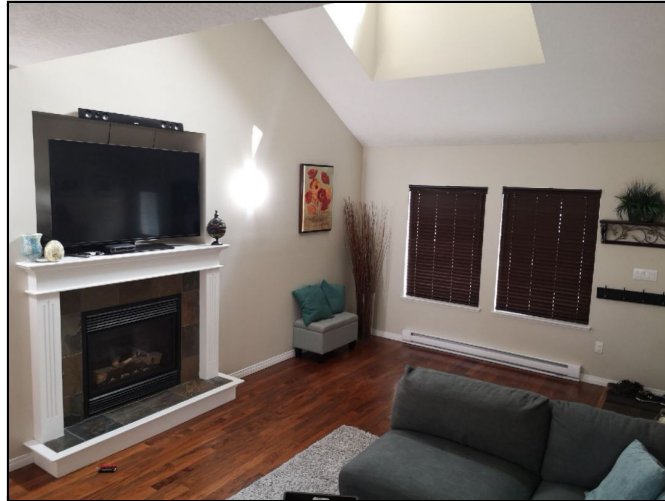
Floor:

Material / Type: Engineered Hardwood

Status: Acceptable, Minor UV staining noted

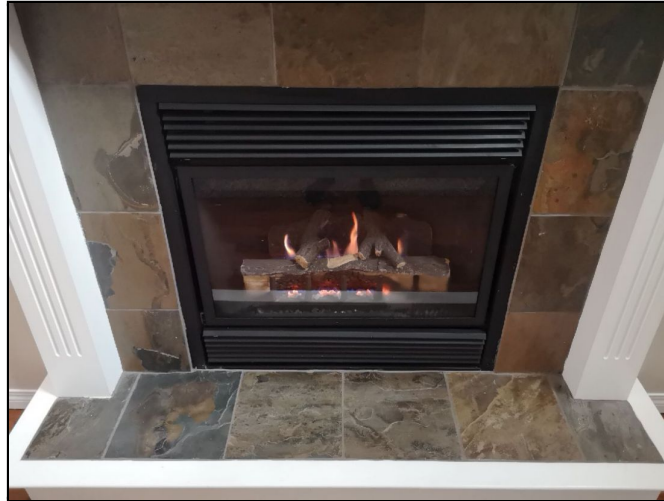
Fire box:

Material / Type: Gas log insert, With thermostatic controlled fan
Description: Thermostat control
Status: Acceptable

Recommendations: Service gas appliances every 1-2 years

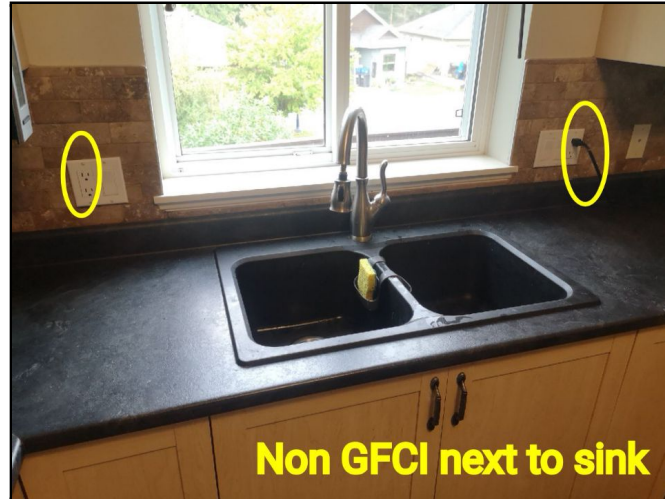
Electrical:

Implications: Shock hazard, Caution, non GFCI outlets next to sink, not required at time of construction
Recommendations: Upgrade outlets next to sinks to GFCI type

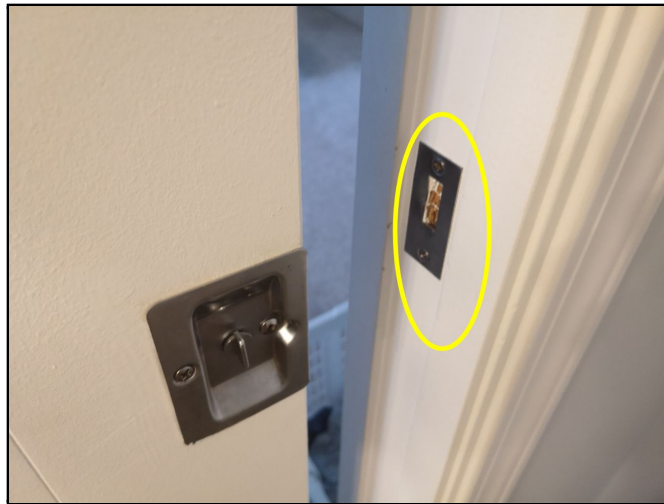
Doors Wood

Status: Acceptable, Does not latch/lock

Implications: Privacy

Recommendations: Repair

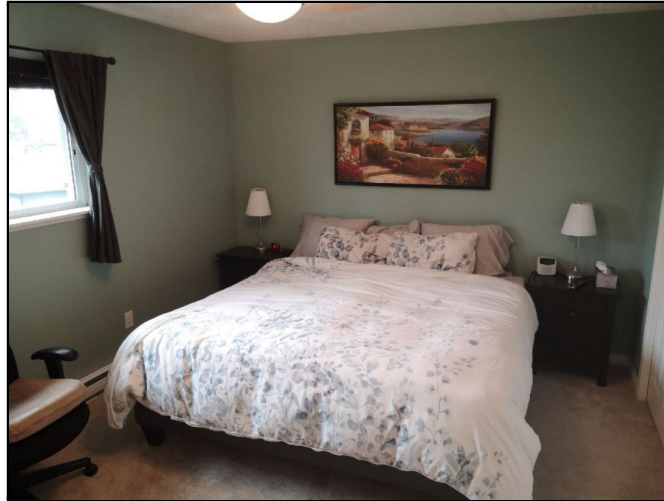
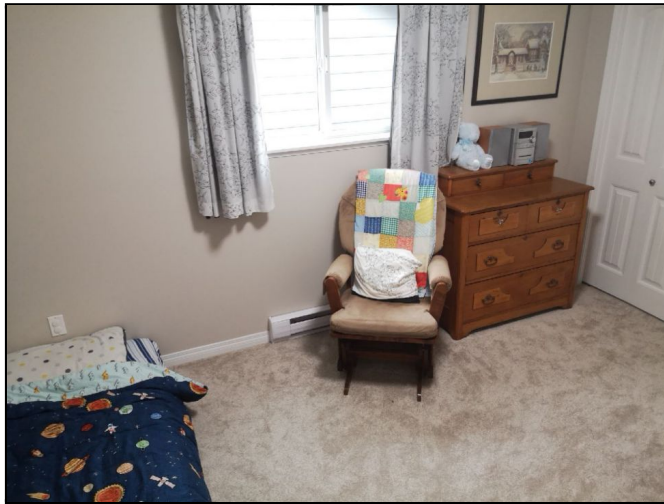
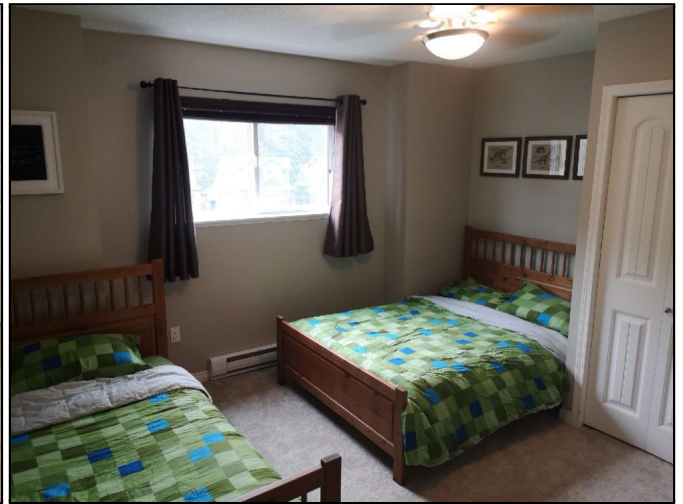
Floor:

Material / Type: Carpet
Status: Acceptable, Appeared upgraded

Recommendations: Minor deflection (squeeking) noted in master bedroom, monitor for any changes

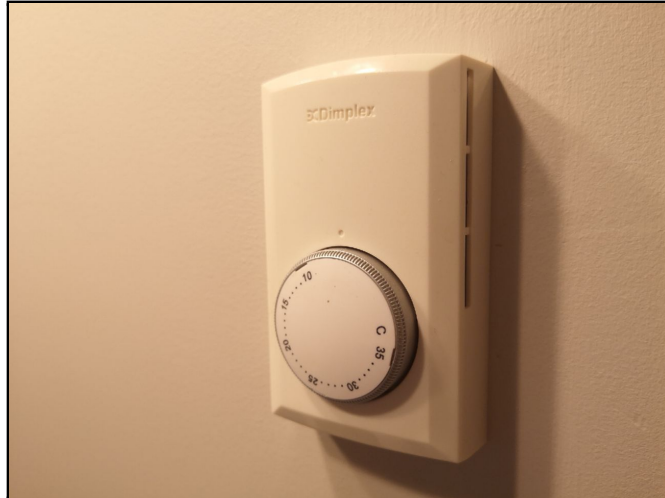
Location: Wall mounted

Status: Acceptable

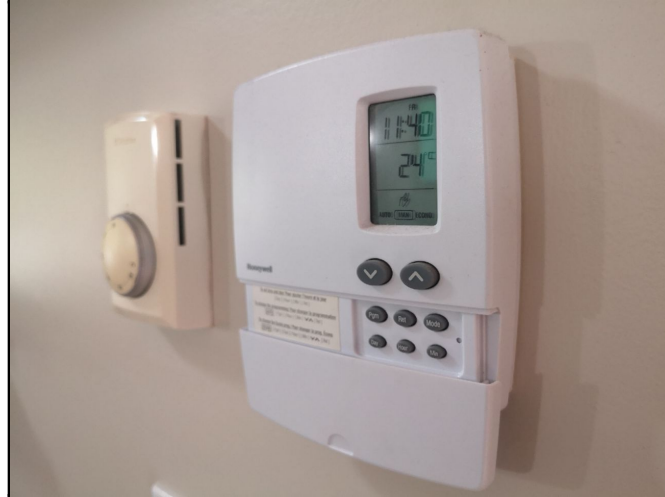
Thermostat Wall mounted:

Material / Type: Programmable, For main living area

Location: Wall mounted

Status: Acceptable

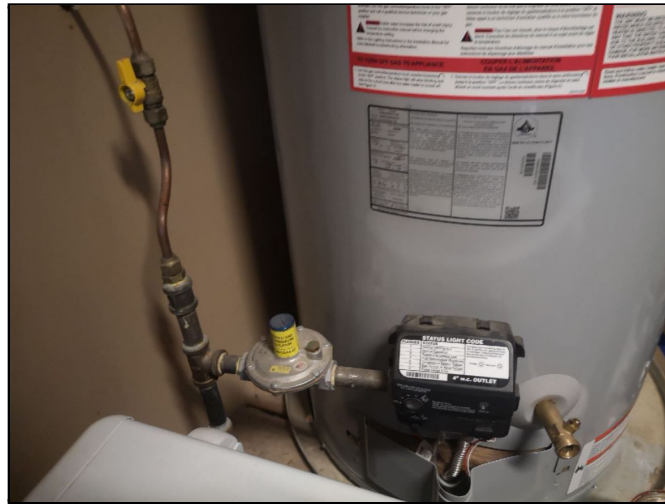
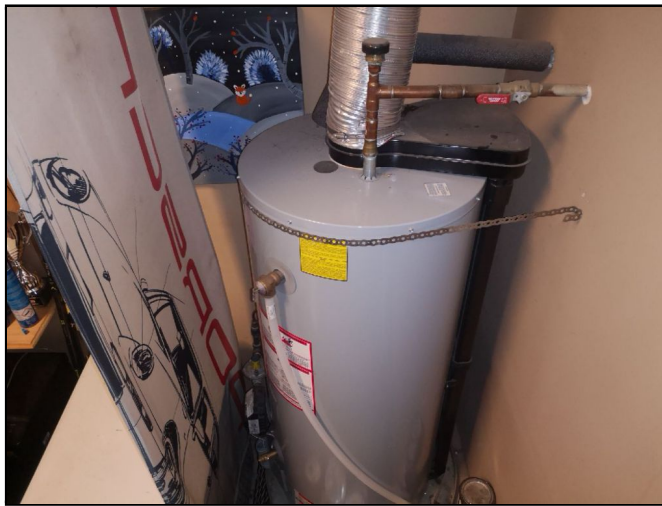
Status: Acceptable

Recommendations: Budget for upcoming tank replacement in approximately 3 years

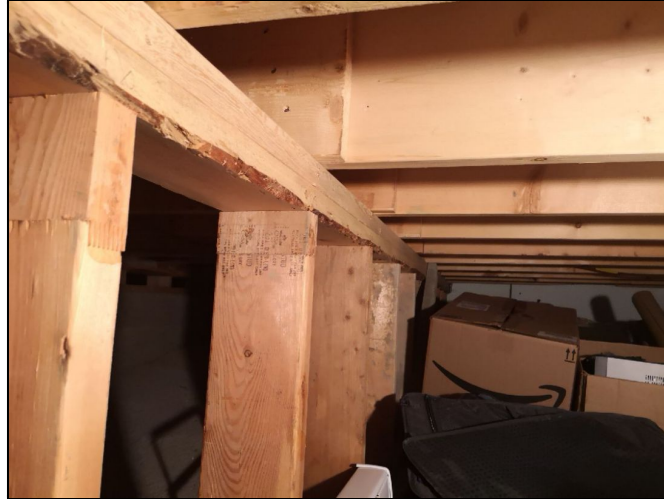
Method of inspection: Partially Visible

Material / Type: Wood frame, 2x6 wall construction

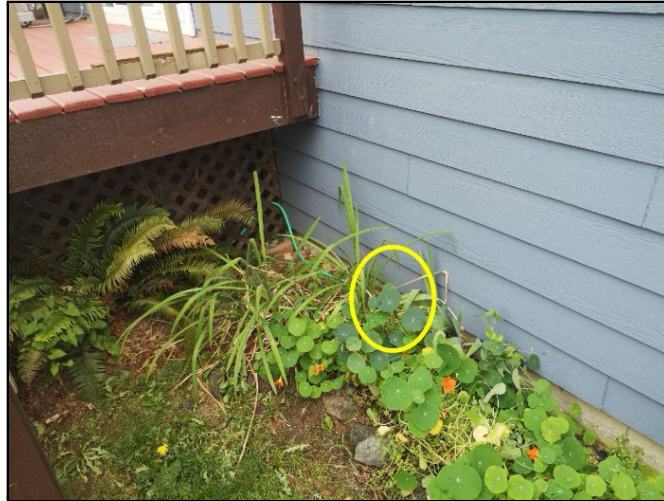
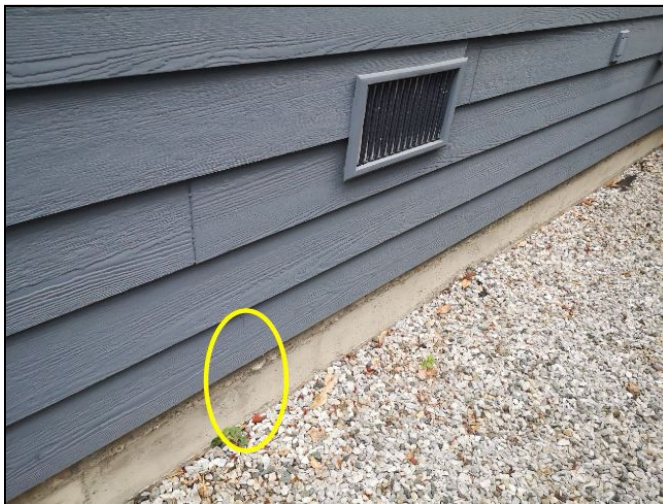
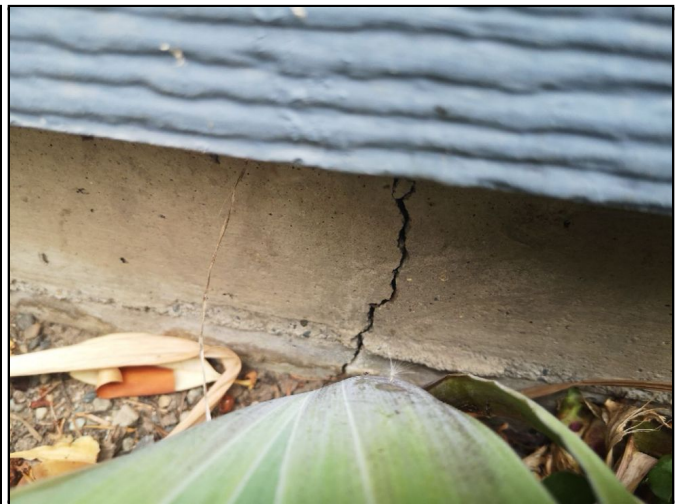
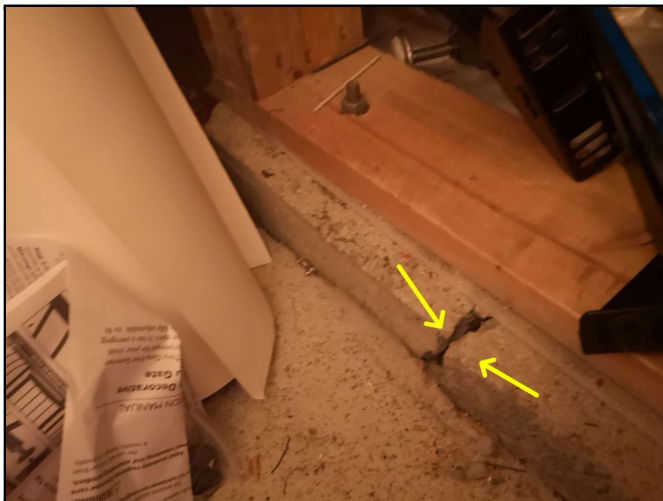
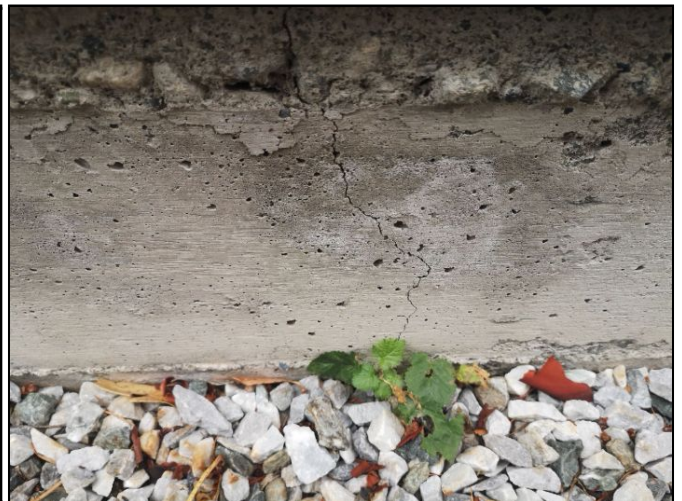
Foundation:

Material / Type: Poured Concrete
Status: Typical settlement cracking

Implications: Minor settlement at time of build
Recommendations: Monitor, Treat perimeter for ants annually

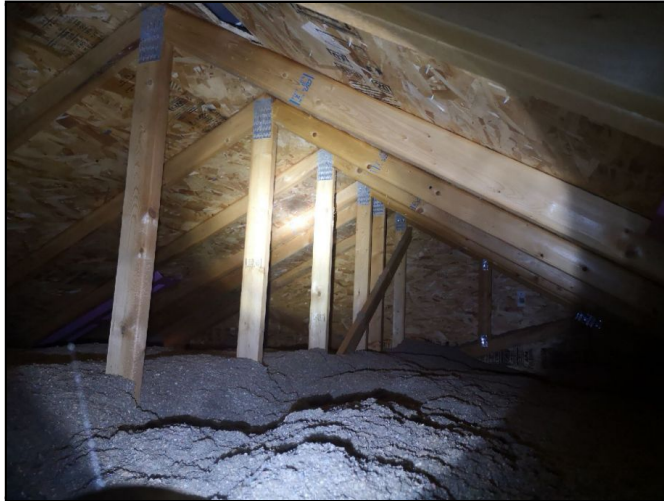
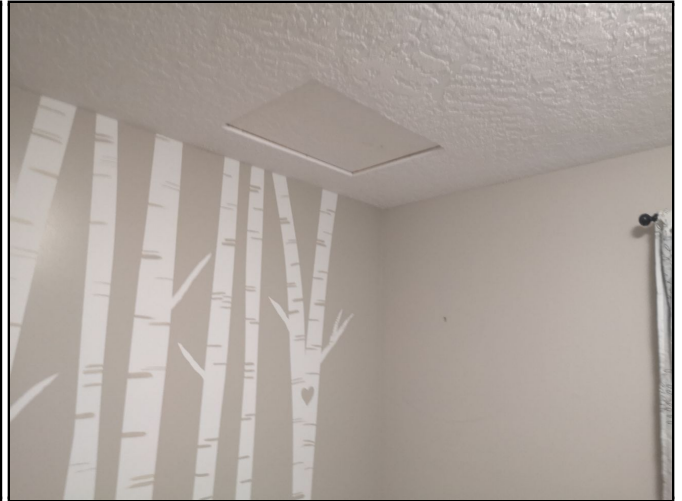
Access Location: 3rd bedroom ceiling

Method of inspection: From Attic Hatch

Material / Type: Drywall, With fibreglass batt insulation
Status: Acceptable

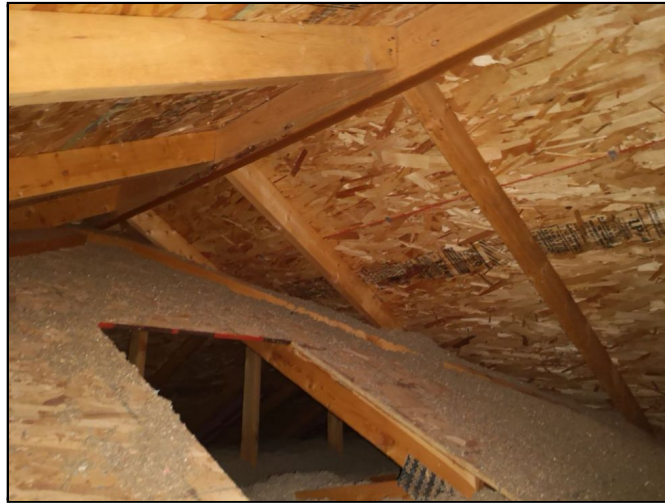
Material / Type: Oriented Strand Board (OSB)

Status: Acceptable

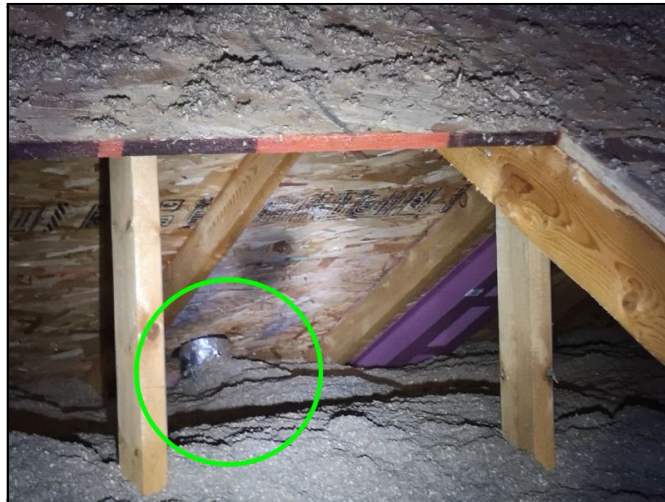
Material / Type: Insulated ducting

Status: Acceptable

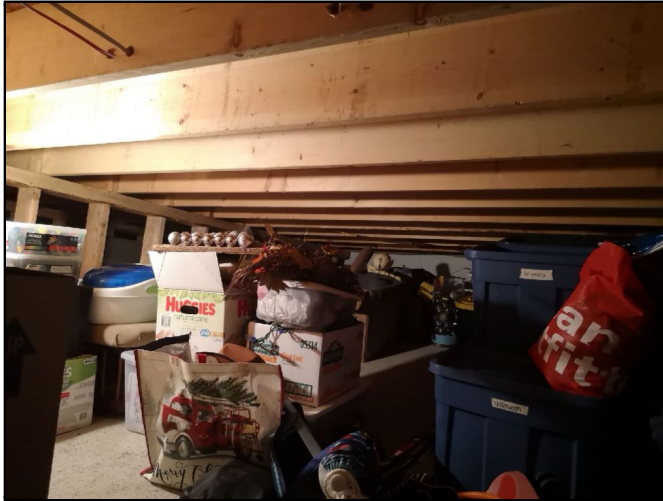
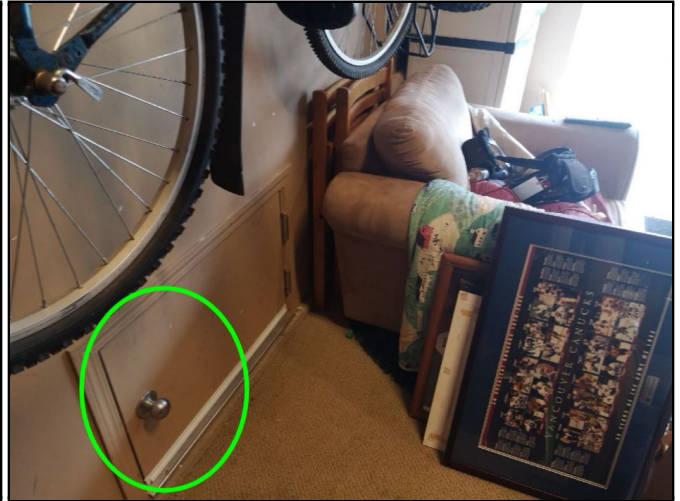
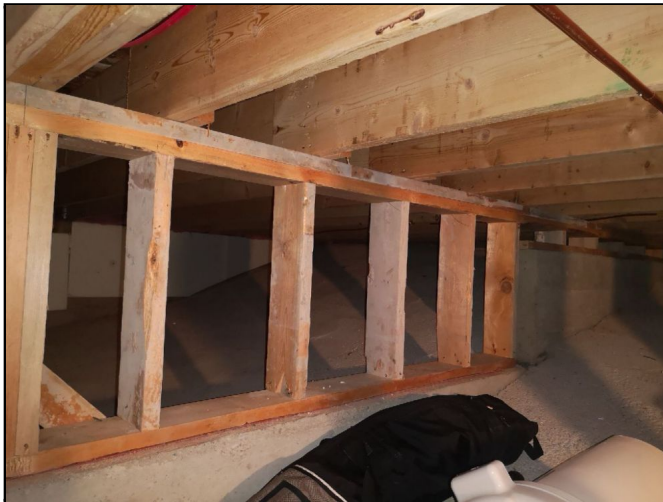
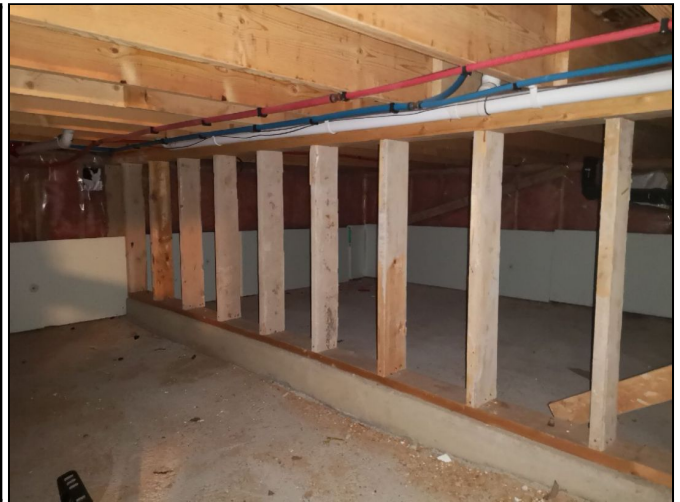
Location: Hatch in garage wall

Method of inspection: In the crawlspace, Limited due to storage

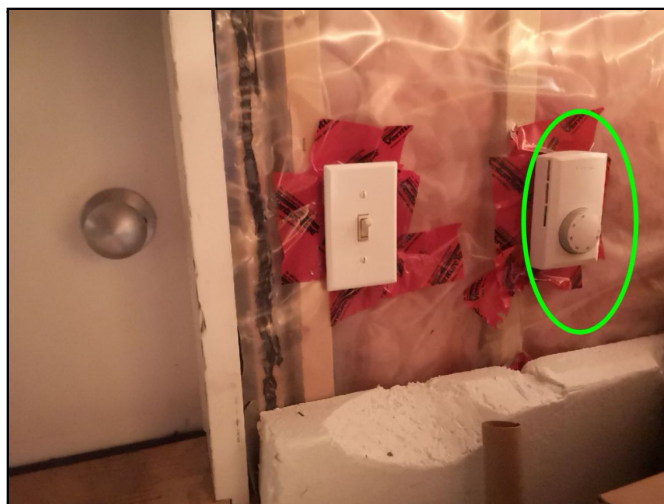
Material / Type: Baseboard heater
Description: Thermostat control
Status: Acceptable

Recommendations: Use sparingly during winter for convection air movement and to prevent freezing conditions in crawlspace

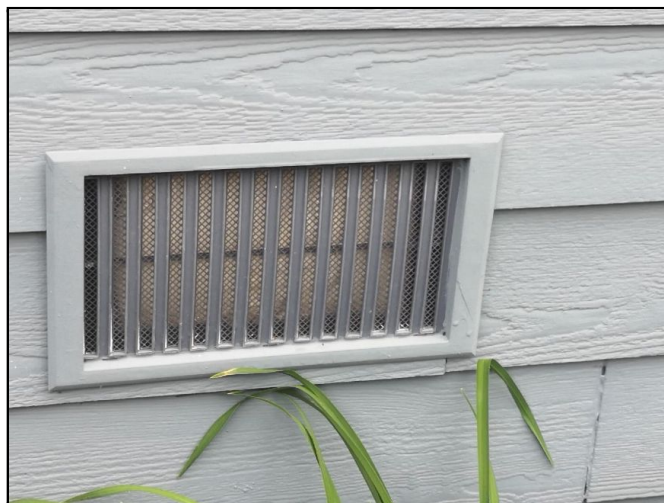
Ventilation:

Material / Type: Vents
Status: Acceptable, Vents appear blocked via insulation

Implications: Poor ventilation, Recommend removing insulation barriers in the spring
